**Degradation of Peel and Tensile
Strength of Bonded Panels
Exposed to High Humidity**

DSTO-TR-1272

**Airframes and Engines Division
Aeronautical and Maritime Research Laboratory**

November 2001

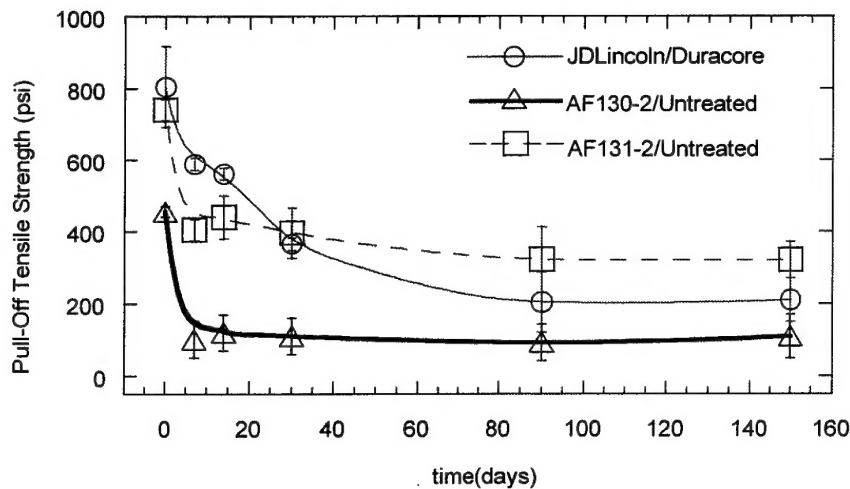
Figure 1 and Figure 2 indicate the change in Tensile and Peel strength of the bonded panels exposed to a 70°C and condensing humidity environment. The tensile strength of all the samples reduces by 400-600psi over a 150 day period. The JD Lincoln and Duracore sample tensile strength degrades gradually over the first 30 days, whereas the untreated honeycomb and AF130-2 and AF131-2 samples both degrade very rapidly in the first 7 days. The peel strength of the JD Lincoln/Duracore sample shows a more rapid decrease than the tensile strength, although the overall reduction does not appear to be as great as the tensile strength reduction. The change in peel strength of untreated honeycomb and AF130-2 and AF131-2 samples is not as marked. Both these adhesives are very brittle and their peel strengths are very low in the control samples. The major information to be established for the exposure of the AF130-2 and AF131-2 samples is the change in failure modes resulting from humid exposure.

Figure 1 Honeycomb panel tensile strength as a function of exposure to a 70°C/100% R.H. environment.

The data in Figure 1 indicates that direct exposure of the fillet bonds to moisture results in a significant reduction in the tensile strength of the honeycomb sandwich panel bonds and a significant increase in adhesion failure. In all cases the majority of the strength reduction and adhesion failure occurs within 30 days. This suggests that should moisture gain access to the bonded honeycomb panel on an aircraft that the reduction in panel tensile strength would be quite rapid. In the case of the AF131-2, the reduction in strength wasn't as marked as the other two systems examined and the percentage of adhesion failure was not as marked. AF-131-2 is used in higher temperature applications on the aircraft and subtle differences in epoxy resin chemistry may improve the adhesive bond formation process during panel fabrication. Generally, the bonded panel tensile strength appears to be inversely proportional to the percentage of adhesion failure and is directly related to moisture diffusing to the adhesive and honeycomb interfacial region and displacing the adhesive bonds from the aluminium honeycomb core surface.

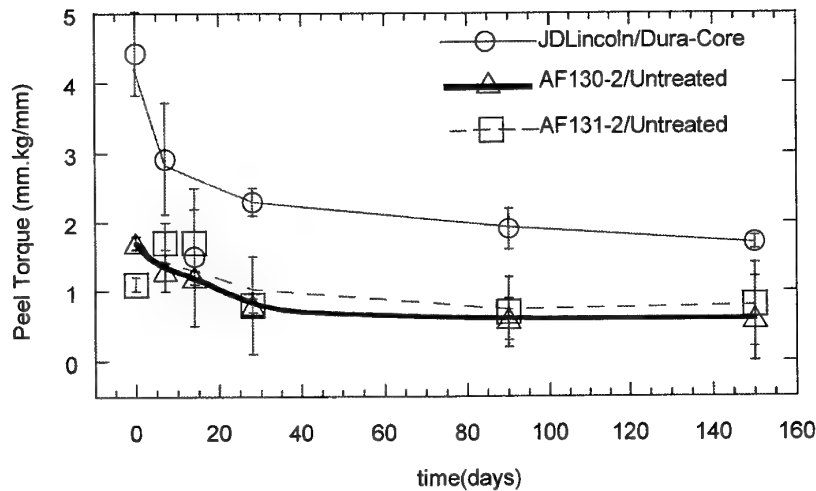
Figure 2 Honeycomb panel peel strength as a function of exposure to a 70°C/100% R.H. environment.

The data in Figure 2 indicates that the change in peel strength for the different honeycomb-adhesive combinations is not as marked as in the tensile strength case. The adhesives tested, particularly the AF-130-2 and AF131-2 adhesives, are brittle and the lack of fracture toughness is shown by the low peel strength values. The newer JD-Lincoln adhesive, shows higher peel resistance, but degrades rapidly in strength once exposed to the moist environment. Both the AF130-2 and JD Lincoln samples indicated that peel strength reduction was associated with a significant increase in adhesion failure either at the skin to adhesive interface or the honeycomb core to adhesive interface. The AF131-2, in contrast, showed a percentage of cohesive fracture of the fillet bond adhesive even after extended exposure, without significant changes in peel strength being observed. The recorded failure modes will provide an important reference for the type of fracture surfaces that will indicate adhesive bond degradation in bonded panels being inspected on the F-111 teardown article in Task Air 00/140.

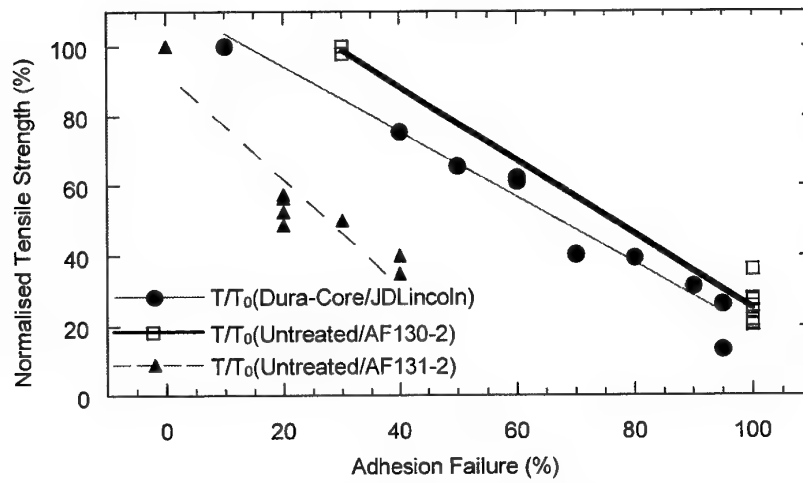
Figure 21 and Figure 22 indicate the measured tensile and peel strength as a function of adhesion failure for the three different honeycomb/adhesive systems. The results suggest that there is an inverse linear relationship between the mechanical strength and the percentage of adhesion failure. Surprisingly, both figures indicate that residual strength remains even when there is 100% adhesion failure. This result may suggest that the mode of failure is caused by moisture diffusion between the adhesive and metal surface of the core or skin material displacing adhesive bonds. The residual strength may indicate that there are still some adhesive bonds that are not disrupted by the interfacial water.

Figure 21 Normalised tensile strength as a function of adhesion failure

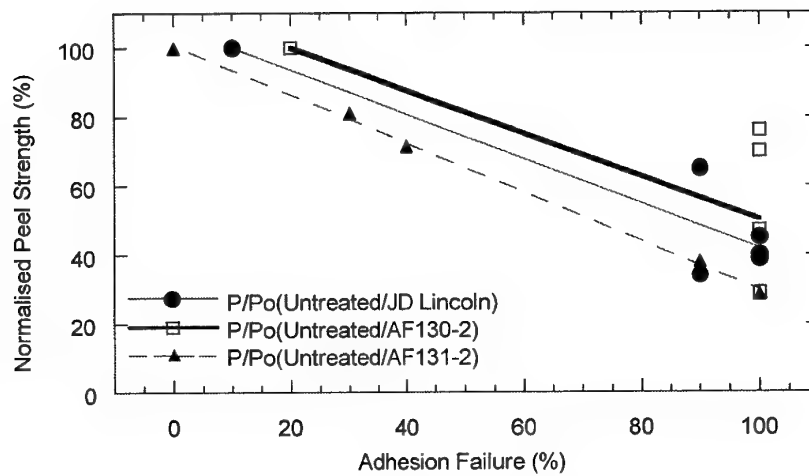
Figure 22 Normalised peel strength as a function of adhesion failure

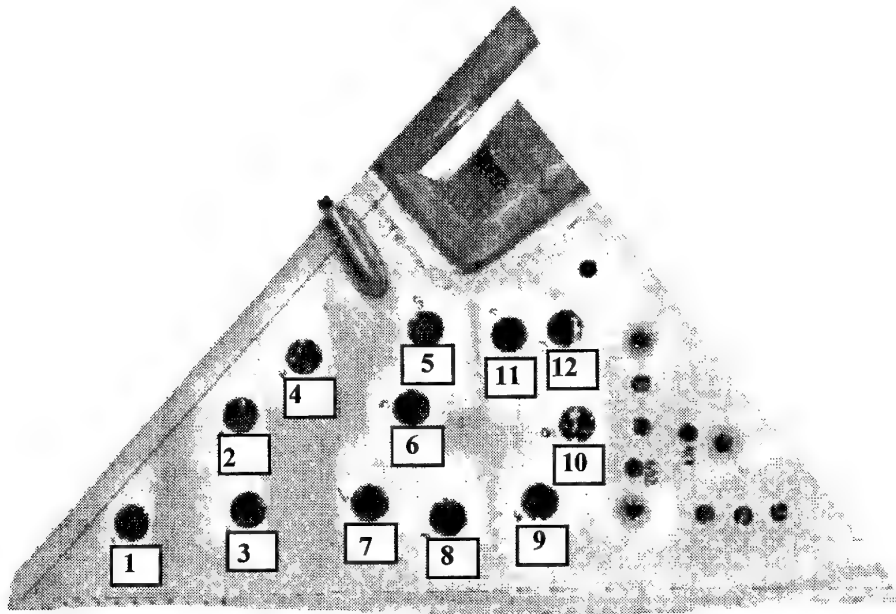
Figure 23 indicates the locations of tensile strength measurements taken on a retired Horizontal Stabiliser Tip (Stab-Tip) from Amberley Air Base. The values for the tensile strength measurements acquired using the portable adhesion tester, refer section 2.2, are provided in Table 2. The average tensile strength value is 590 psi with a standard deviation of 100psi. All the samples either failed as a result of core fracture or cohesive fillet bond failure or a combination of both of these failure modes. The honeycomb had a cell size was 0.25" and the foil gauge was 3.4pcf. Typically, the core fracture is seen for honeycomb with these dimensions and the values around 600psi are acceptable values for undegraded honeycomb structure

Figure 23 Locations of tensile test measurements taken from the Stab-Tip, prior to conditioning.

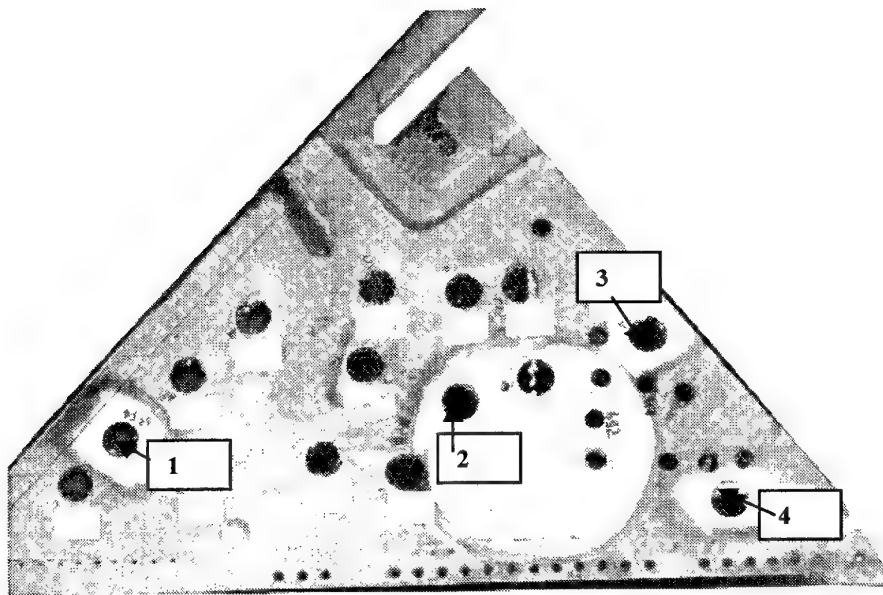
Table 2 also indicates tensile values for samples taken from the Stab-Tip after 20 days and 13 months of immersion in 50°C water. The location of the tensile test measurements are provided in Figure 24 to Figure 26. The data suggests that after 20 days little effect in bond strength results, although a low value of 320psi was recorded for a cohesive failure of the fillet bond adhesive. A similar value and failure mode was observed for a test taken after the Stab-Tip was immersed for 13 months in the 50°C water. It is not clear whether this strength reduction is due to adhesive degradation or not. After 13 months of immersion the Stab-Tip indicated two samples with low values between 200-300psi that failed as a result of core corrosion. Two samples that indicated the onset of fillet bond pull-out did not indicate significant decreases in bond strength. This data suggests that an important factor that may lead to degradation of panel mechanical properties will be due to core corrosion. There is also some suggestion that fillet bond pull-out may occur for extended exposure of bonded panels to humid conditions. Failure surface images of core fracture, core corrosion and fillet bond pull-out are shown in Figure 27 to Figure 29. Generally, the results from the Stab-Tip immersion experiments suggest that in cases of well sealed panels, moisture diffusion into the panel is very slow.

Figure 24 Locations of tensile Test measurements taken from the Stab-Tip after conditioning in 50°C ionised water for 20 days.

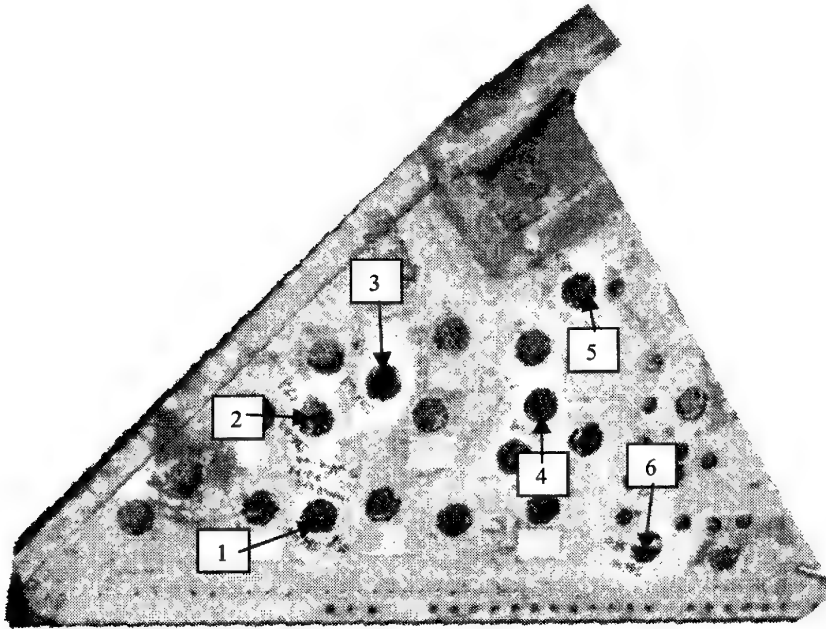
Figure 25 Locations of tensile test measurements taken from side 1 of the Stab-Tip after conditioning for 13 months in 50°C ionised water.

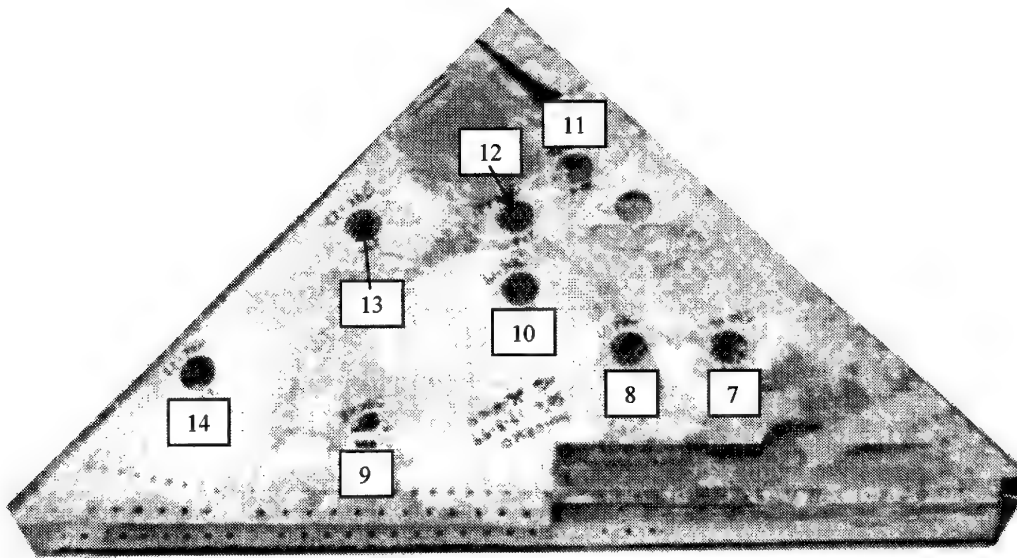
Figure 26 Locations of tensile test measurements taken from side 2 of the Stab-Tip after conditioning for 13 months in 50°C ionised water.
